Adhesion Pulley & Brick Testing White Paper

Vincent T. Vu, Product Development Chemist

June 14, 2016

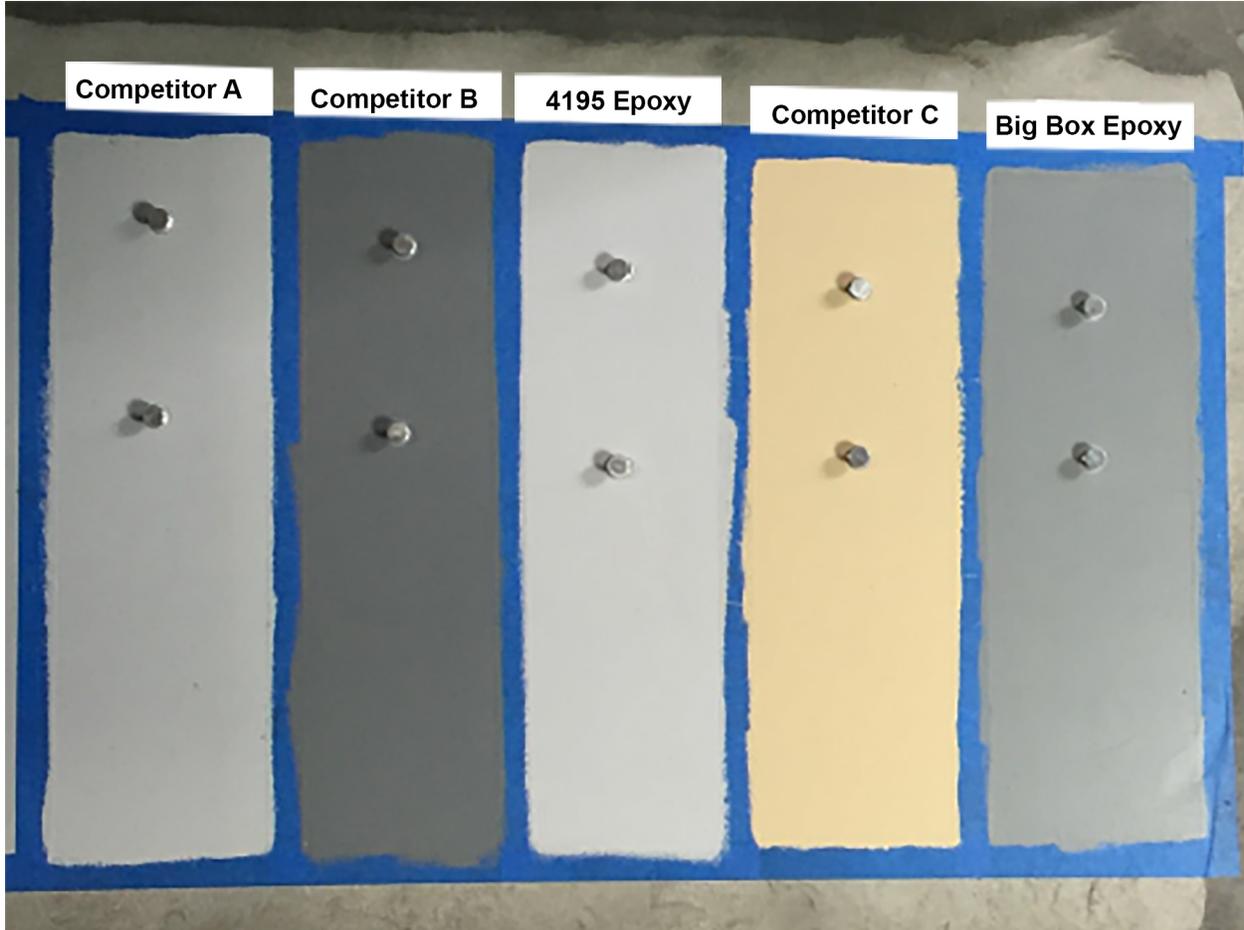
Img 1. Elcometer adhesion pulleys were attached to the coating and the coating was allowed to dry to a full cure at ambient temperature.

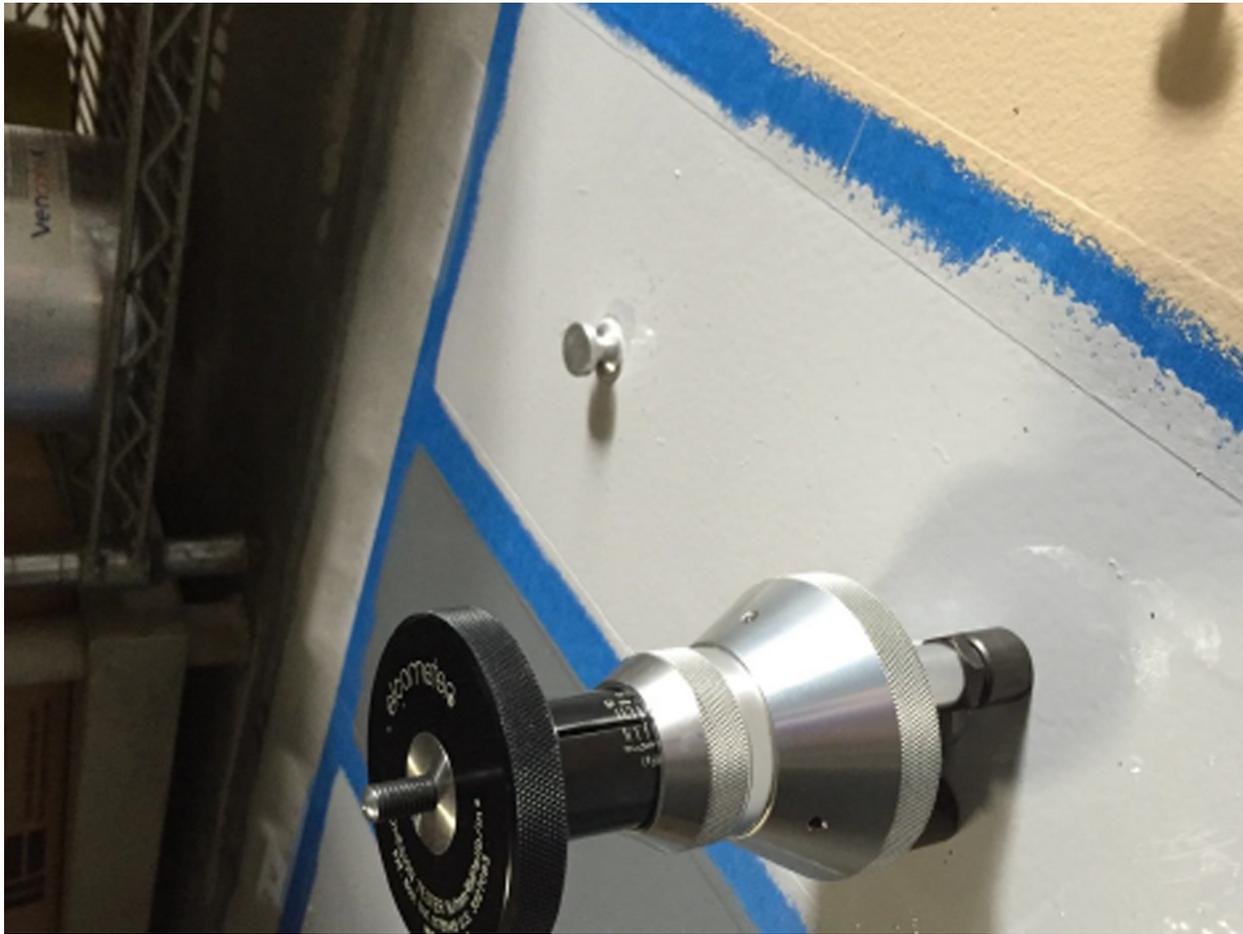
Img 2. Elcometer adhesion puller was attached to adhesion pulleys and adhesion tests were performed.

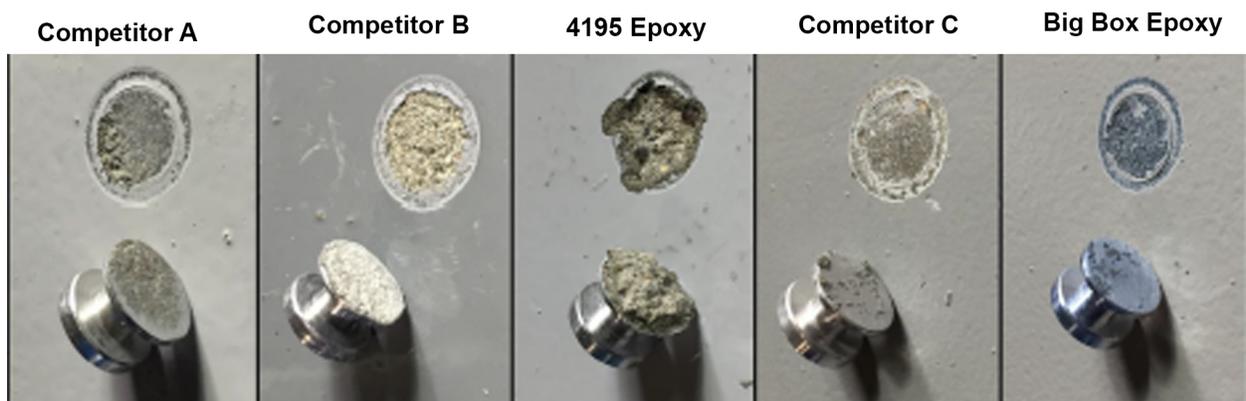
Img 3. Adhesion results. 4195 was most effective at adhering to the concrete floor. 4195 also removed the most concrete from the floor during the adhesion pulley test. This proves that the 4195 is far superior at wicking/anchoring itself into the concrete surface compared to the other competitor coatings.

A total of five different epoxy primer/sealers were tested in the adhesion pulley test. Each component was thoroughly mixed for several minutes to ensure that there was no settling of pigments or additives. The resin and hardener components were measured out according to the manufacturer volumetric ratios and mixed for several minutes. A first coat was applied over a taped area on the freshly prepared and cleaned concrete floor with the use of a four inch wide 3/8 inch nap roller. The product was allowed to cure for four hours before a second coat was applied. Once the second coat was applied, two Elcometer adhesion pulleys were placed on the wet product (*img 1*). The coated area was allowed to cure for ten days at ambient temperature during mid-May with no rain or high humidity during the curing process. The surrounding coating was cut with a pulley cutter to ensure that the adhesion results were correct. The Elcometer adhesion puller was attached onto each pulley (*img 2*) and the adhesions results were recorded (*table 1*). Images of the results were photographed (*img 3*).

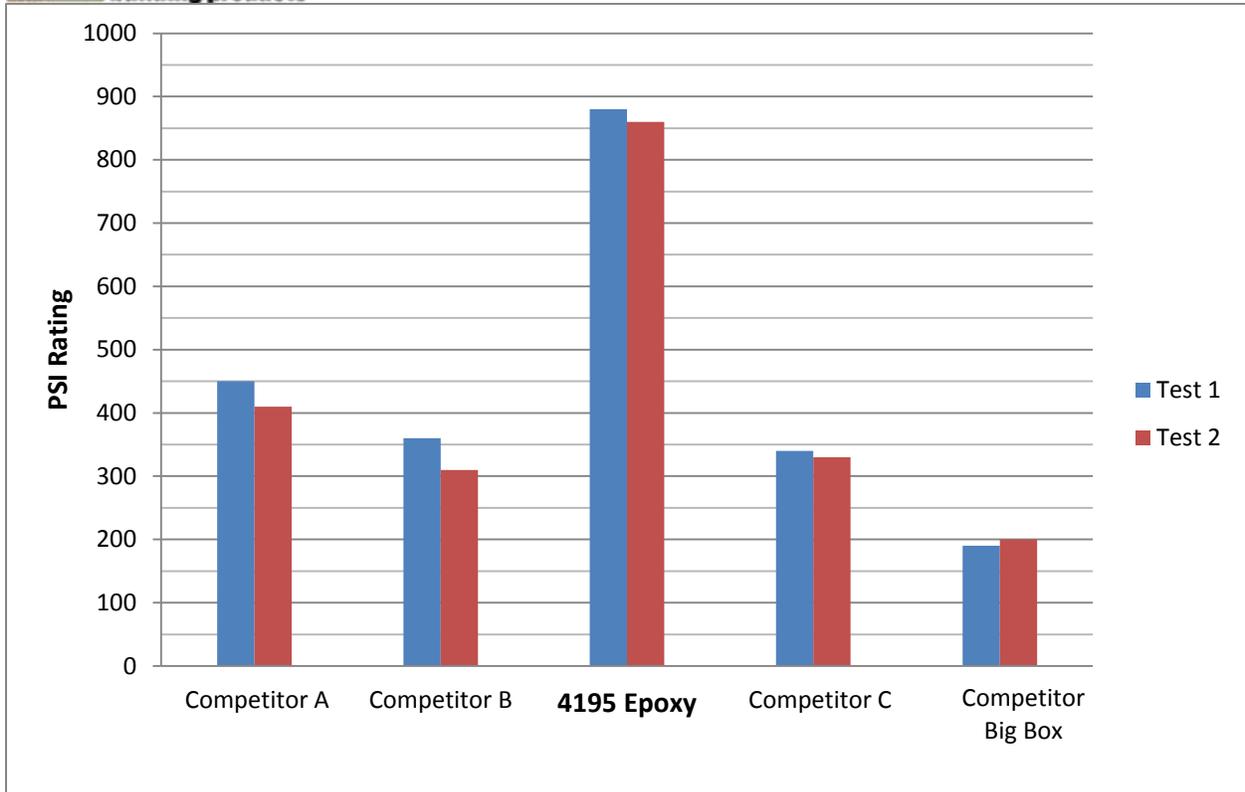
Table 1. Bar graph of adhesion values for various floor coating primers show that 4195 has more than two times the adhesion of most of the competitive products sold into the garage flooring market. This will result in less failures

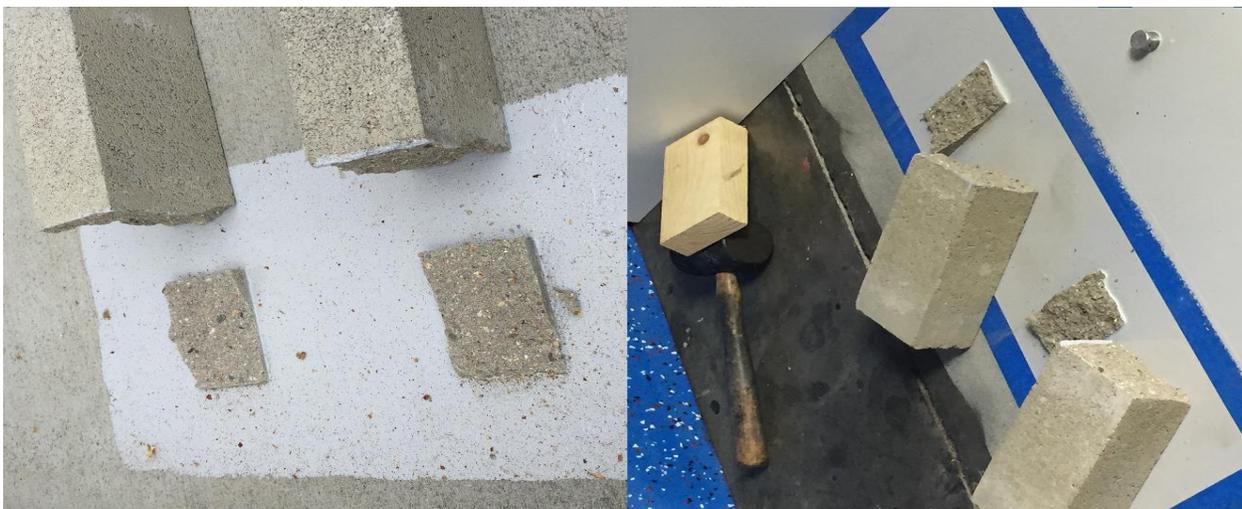
Img 4. Brick test results for behind VBP building (left) and VBP warehouse floor (right). The bricks broke on both tests due to the fact that the brick was the weakest product. The coating did not fail, and the concrete floor did not fail.

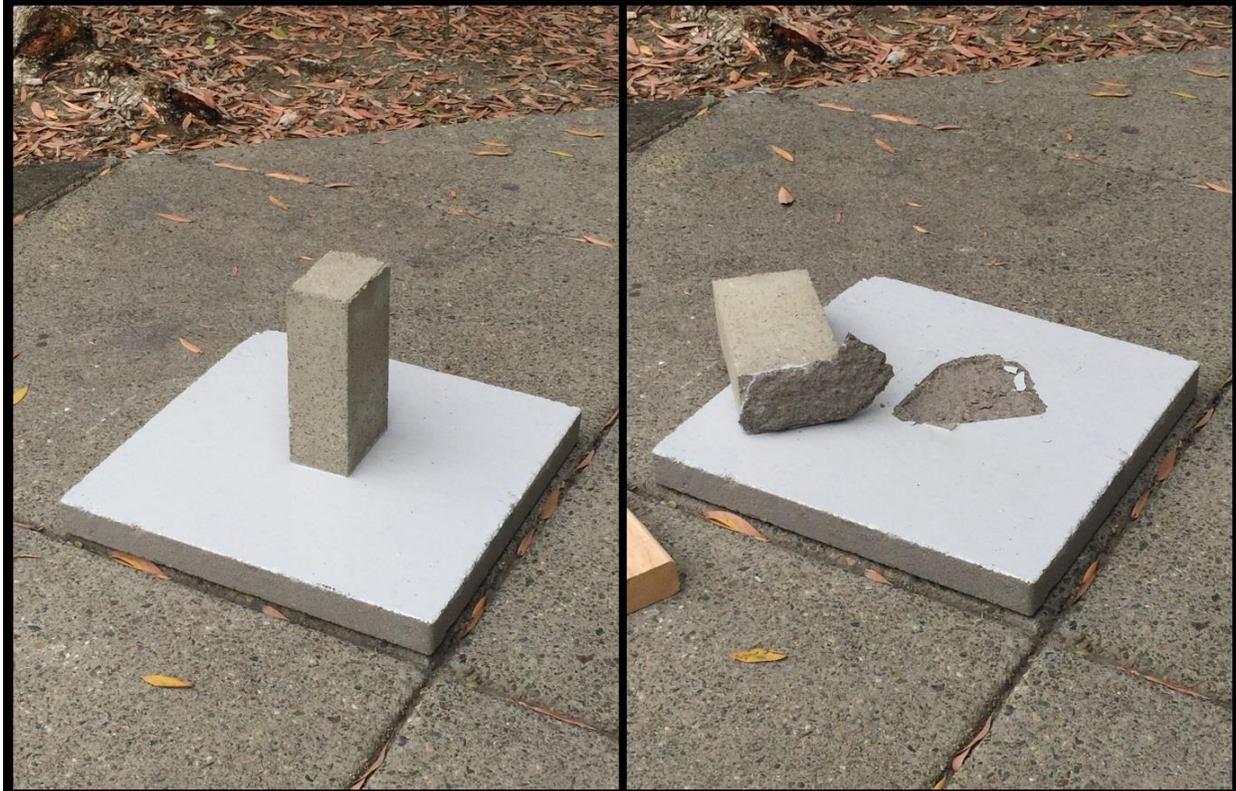
Img 5. VBP 4195 brick test. The coating adhered extremely well to the concrete tile. It took 3 forceful impacts with a mallet to separate the brick from the concrete tile. The coating tore off large sections of concrete due to the wicking technology of 4195.

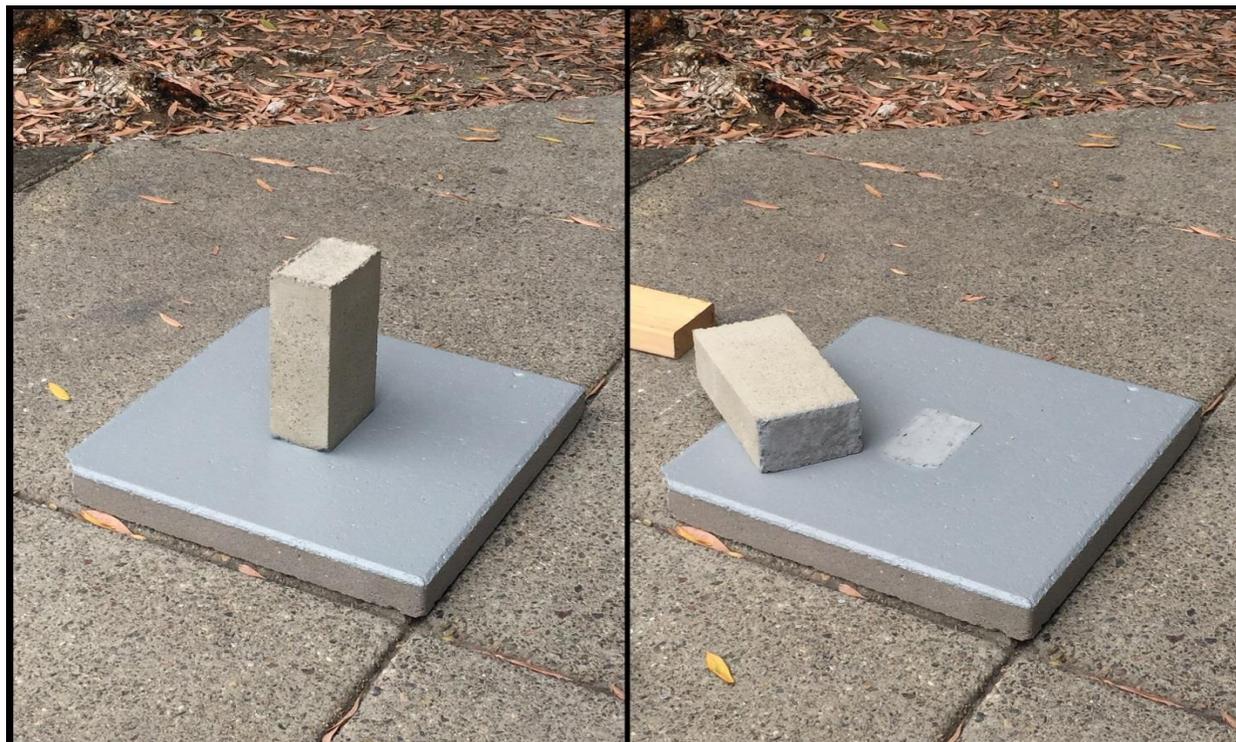
Img 6. Competitor Big Box Floor Coating brick test. The brick came off extremely easily. The coating failed and the concrete tile was left intact. The brick was also completely intact. The coating failed to adhere the brick and the concrete tile.

The 4195 was mixed according to the manufacturer recommendations and applied over three separate areas (concrete tiles, VBP warehouse floor, and a concrete area behind the VBP building). A second coat was applied after four hours, and a concrete brick was placed on top of the coated surface. The coating was allowed to cure for ten days at ambient temperature during mid-May with no rain or high humidity during the curing process. Once cured, a block of wood was used to distribute force on the brick while a rubber mallet was used for impact. The results were photographed (img 4 and img 5), and the best resulting surface (concrete patio stone) was used for testing with competitor products. The two competitor products chosen were Competitor B (Professional Garage Flooring Epoxy) and a Competitor Big Box (DIY Epoxy). The same test was performed for the Competitor Big Box product and the results were photographed (img 6).
